A  
TRAGIC  
NAVIGATION  
ERROR

DON WHITEFIELD  
DEPUTY LEAD NAVIGATOR  
W.L. UEBELHOER PILOT  
SEPT. 27, 1944

## KASSEL MISSION

September 27, 1944

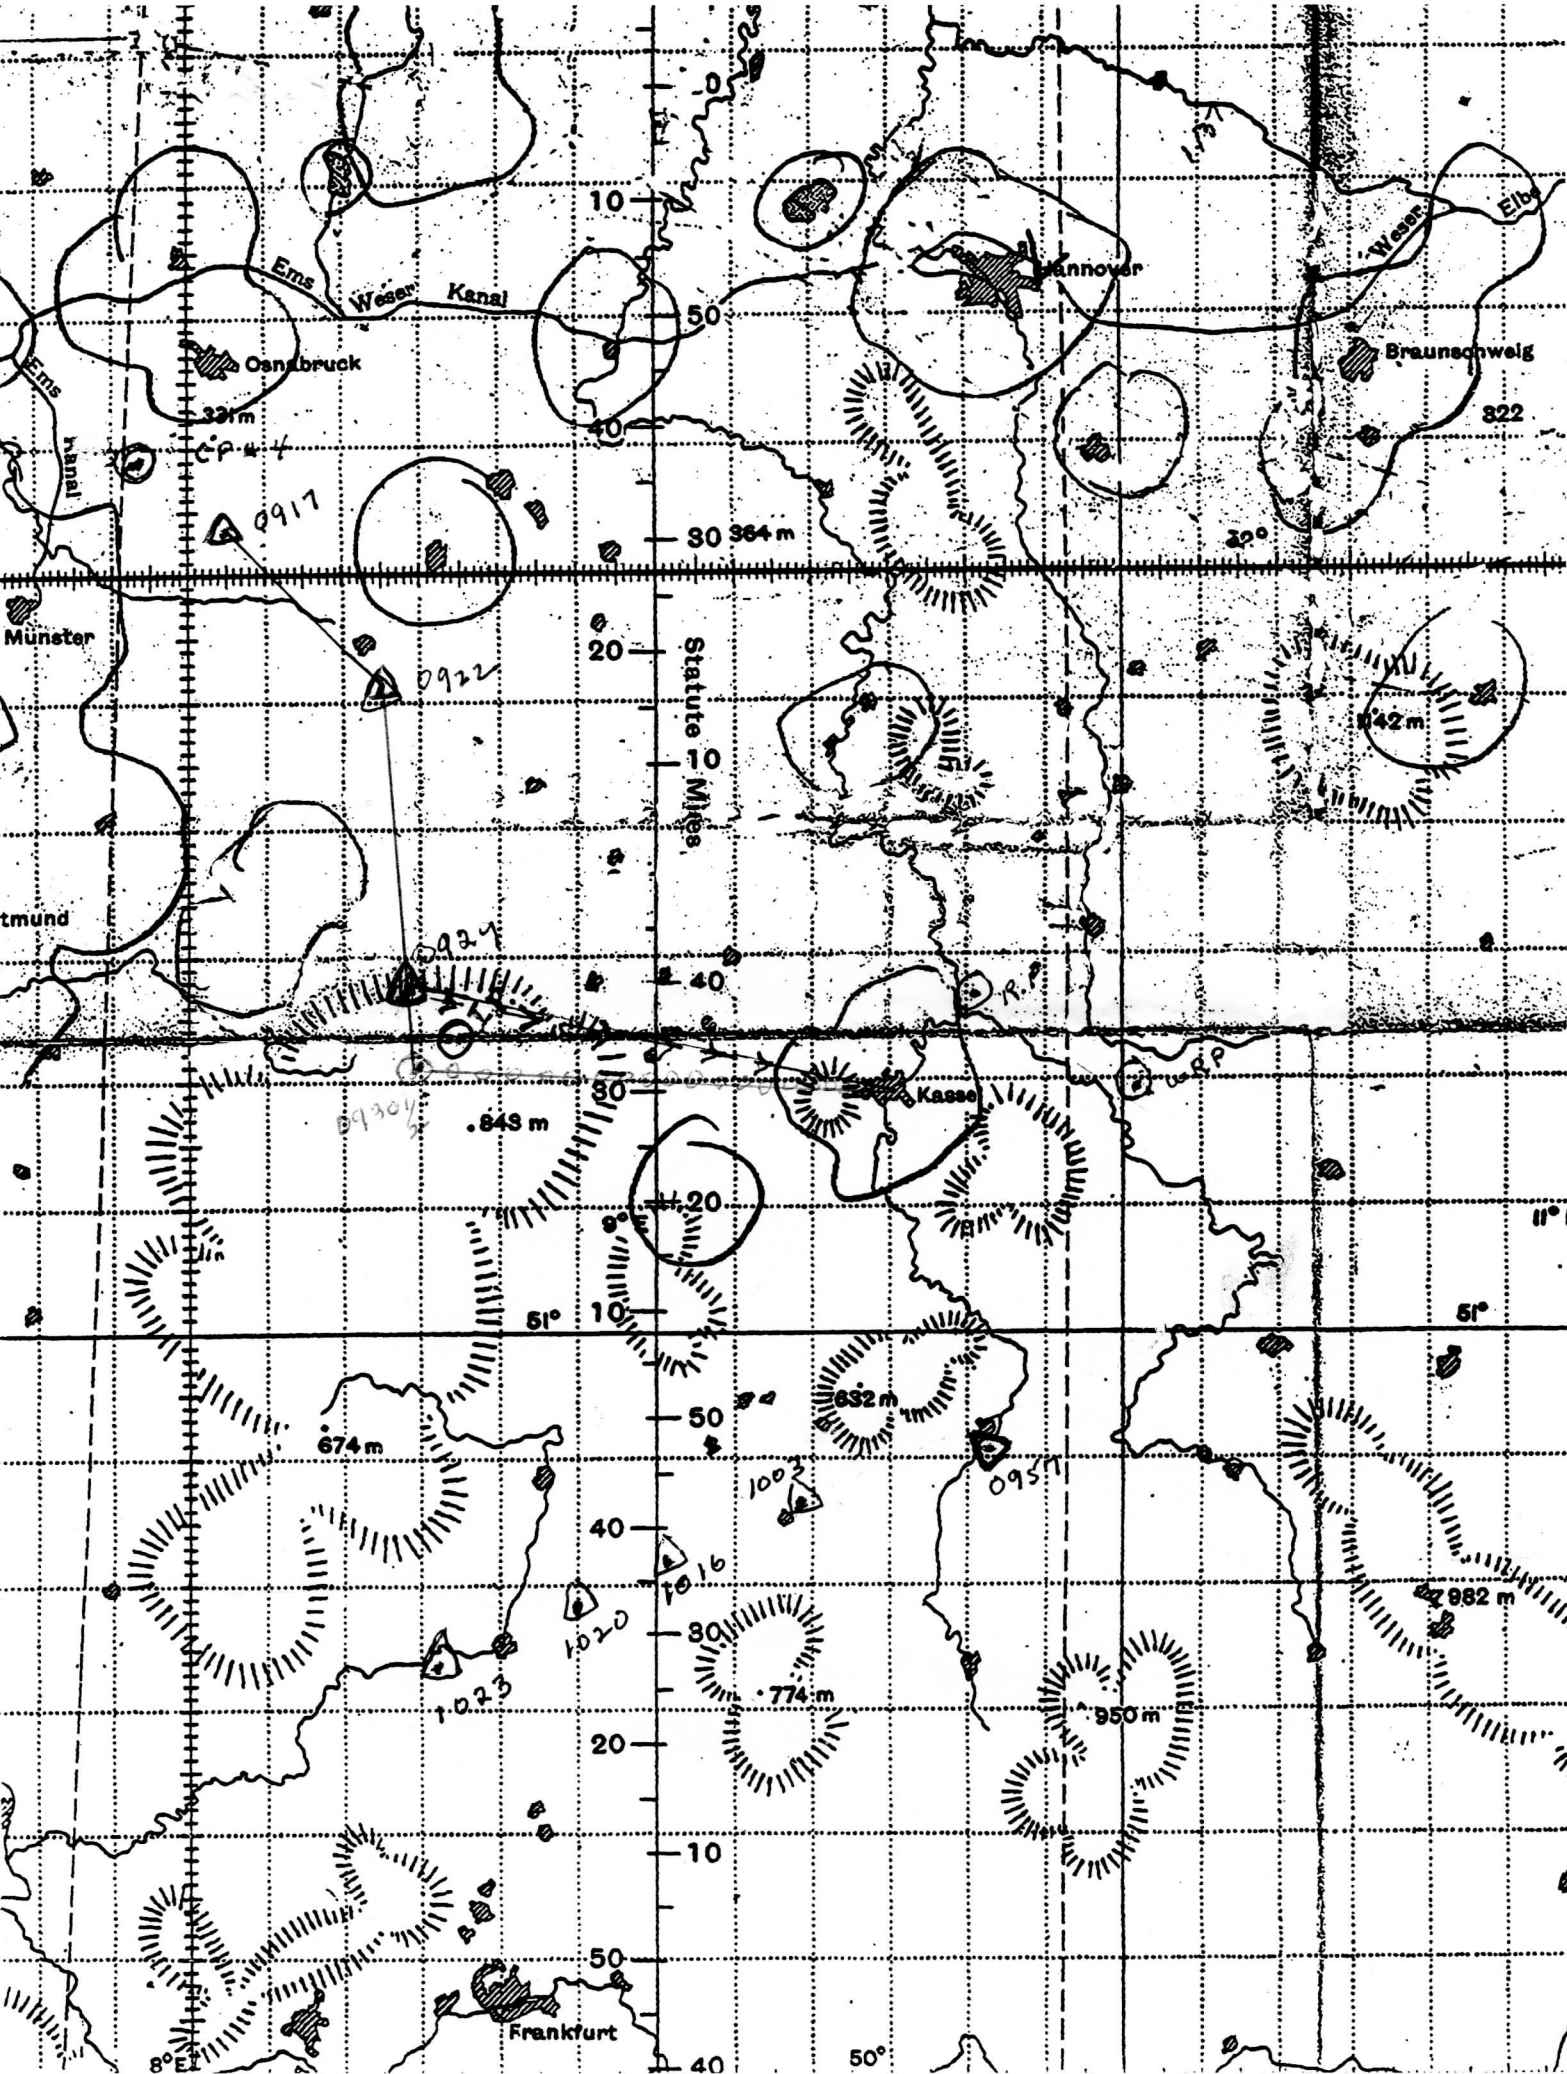
TC 92  
TAS 209  
Drift -4  
GS 270  
TH 088  
ETA 8 ½ M  
Dist 38 K

The 102 heading at the mickey fix would have been  
Used since it would have put us almost through the IP

From the 0917 fix there are two overlays to show track to bombs away
